Maryland
Department of
the Environment

Overview of Mountain Christian Church Drainfield System

C. T. Tien, Ph.D., P.E.
Deputy Program Manager
Wastewater Permits Program
Water and Science Administration
Maryland Department of the Environment

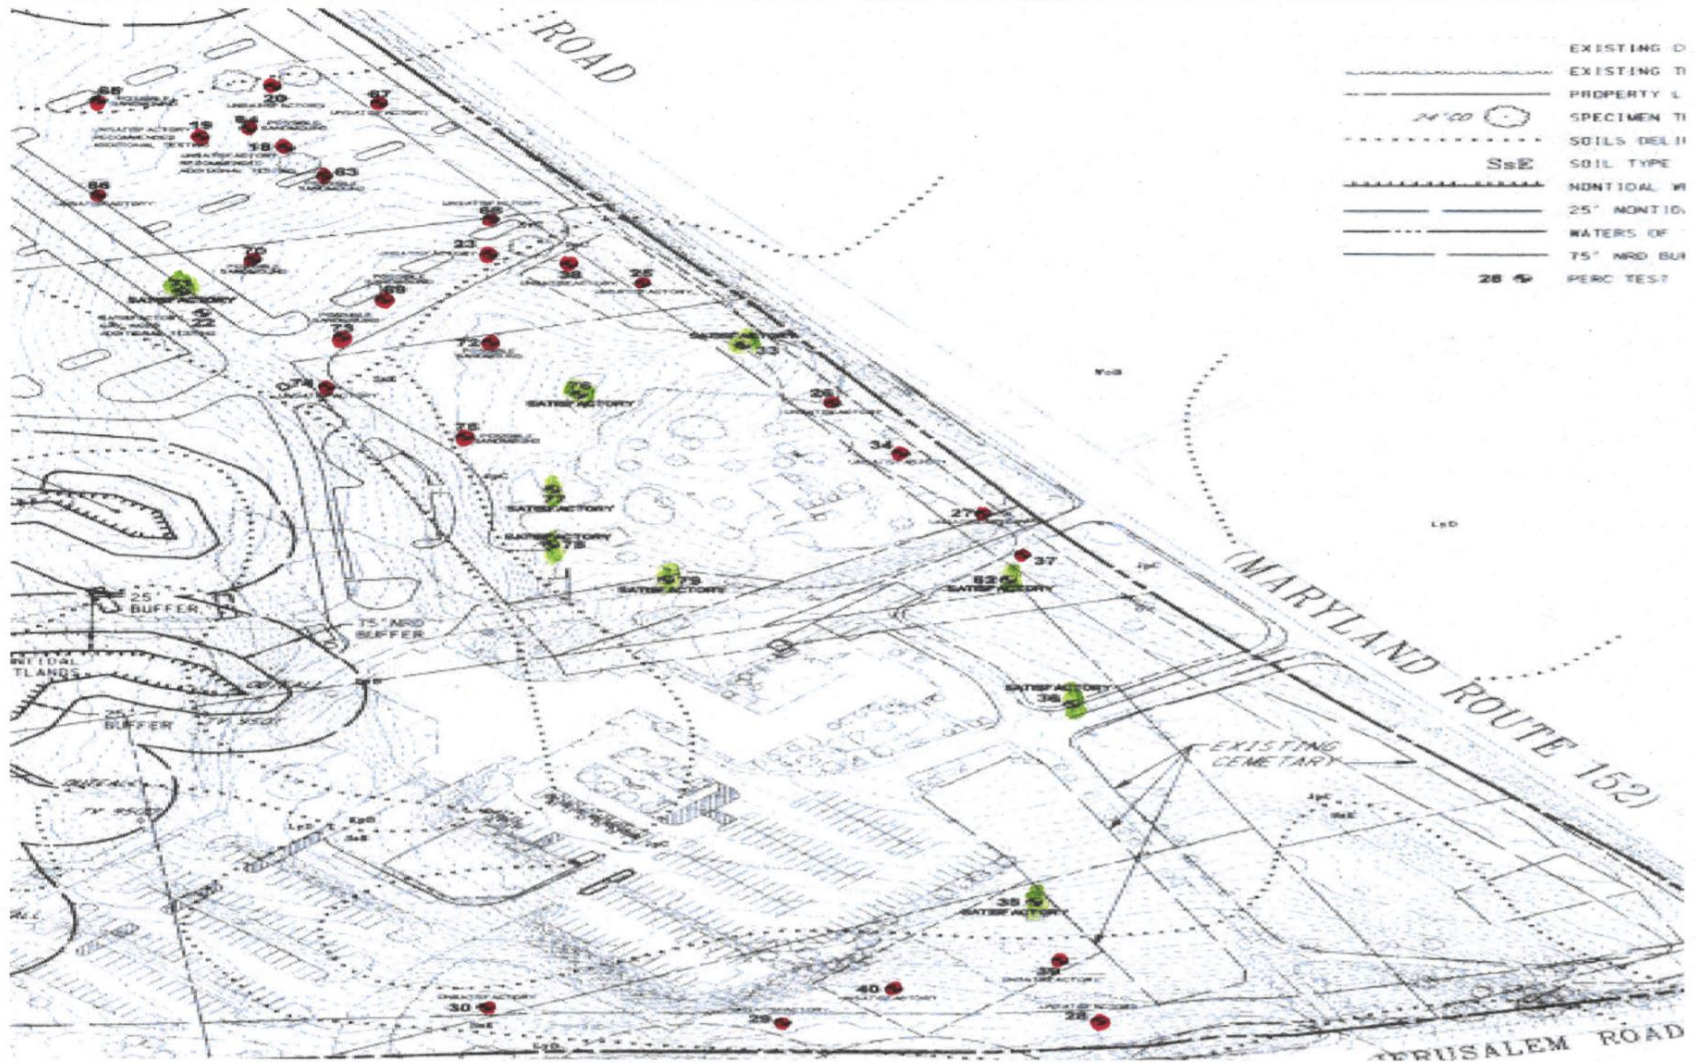
Locations of Soil Test Pits Evaluated in 1998 and 2002

1. Harford County Environmental Health Department evaluated soil test pits along Route 152 and Jerusalem Road in 1998 and again in 2002.
2. At that time, 18 test pits were thought to involve “satisfactory” soil and groundwater characteristics for drainfield system installation, 54 test pits were considered in the “unsatisfactory” category.
3. A sand mound system repair is not considered possible at this site since it requires a much larger surface area and uses a much lower loading rate than the 1.2 gal/day/sq ft loading rate used for the existing trench system design.
4. One area with four “satisfactory” test pits (No. 76, 77, 78 and 79) close together was selected as the current drainfield site.
